(NASA-TM-X-70381) EVALUATION OF GROUND
CHARACTERIZATION SAMPLES MCN-2 AND MCN-3,
SECTION 1 (NASA) 56 p HC \$6.00 CSCL 13H

SECTION I. EVALUATION OF GROUND CHARACTERIZATION
SAMPLES MCN-2 AND MCN-3

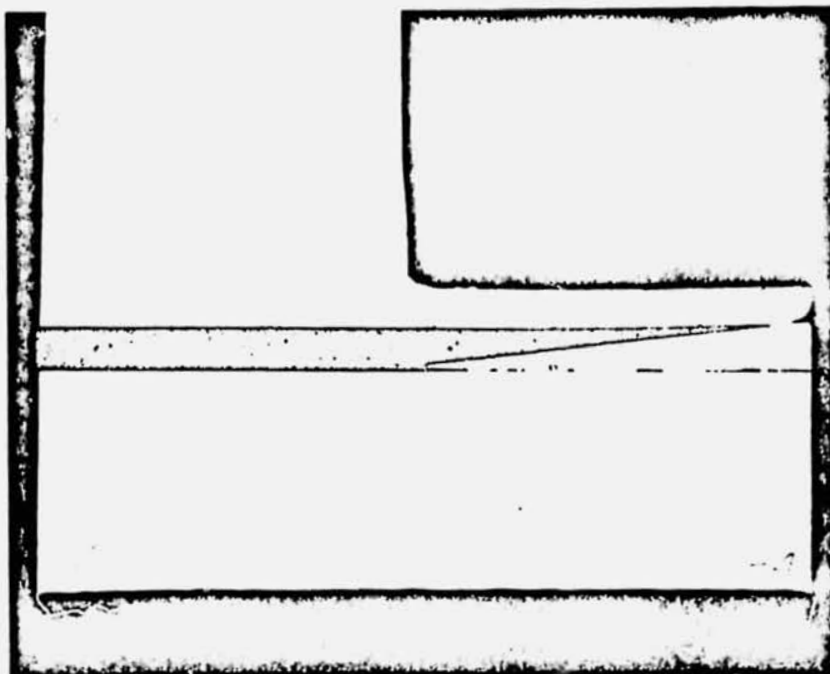
FIGURE I-3. SECTION MCN-2-1

One side of the joint in this section is shown at a magnification of 20X in Figure I-3. The joint quality is excellent; the filler metal wet the base metal well and flowed to completely fill the joint between the tube and sleeve. The insert used to maintain the spacing between the tube and sleeve was brazed to the remainder of the assembly. A few isolated voids were present in the joint area. The other side of the joint had an appearance similar to that shown in Figure I-3.

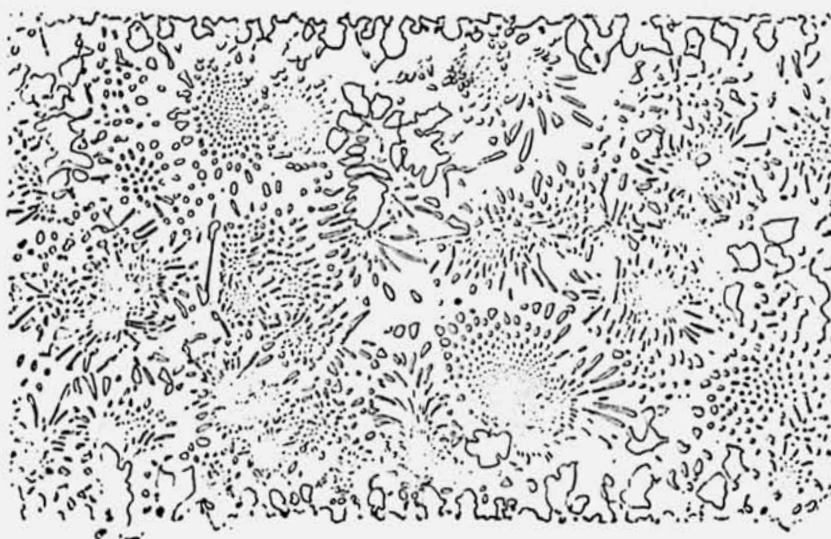
FIGURE I-4. SECTION MCN-2-1

Selected areas of this joint are shown in the as-polished condition at 250X and 500X in Figures I-4 and I-5, respectively; the area covered by Figures I-4 is also shown in the etched condition at the same magnification in Figure I-6. The microstructure between the joint interfaces is largely comprised of a eutectic phase and a phase that appears to have been formed by the reaction of the filler metal with the base metal. Etching appeared to have the same effect on this phase as it did on the phase along the joint interface. The dissolution of the base metal by the molten filler metal is clearly evident in the attached photomicrographs. The width of the zone resulting from this reaction was about 0.001 inch.

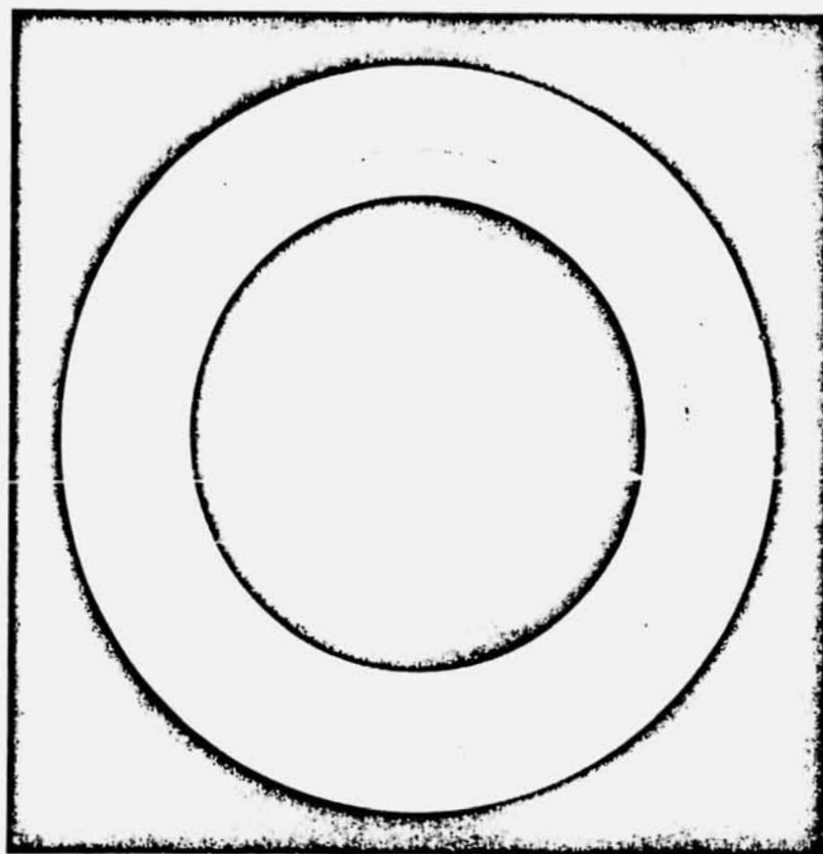
FIGURE I-7. SECTION MCN-2-2 *3 mm*

The full circumferential joint between the nickel tube and sleeve is shown at 4X in Figure I-7. The quality of this joint was generally excellent except for an accumulation of voids that are evident at the 12

o'clock and 3 o'clock locations in Figure I-7. (The 3 o'clock position corresponds to the location of the isotope tracer in this sample.) These voids, one of which extended across 70 percent of the joint, could have formed as the result of insufficient filler metal in this area. They could have also formed if filler metal drained from this area into an area deficient in filler metal. Their presence was not noted in the interpretation of the radiographs of this sample. Voids at the 3 o'clock location are shown at 250X in Figure I-8.

The average joint clearance, 0.0095 inch, was just slightly less than the design clearance of 0.010 inch. The tube was well-centered vertically in the sleeve, but was offset slightly (toward the 3 o'clock location) in the horizontal orientation.

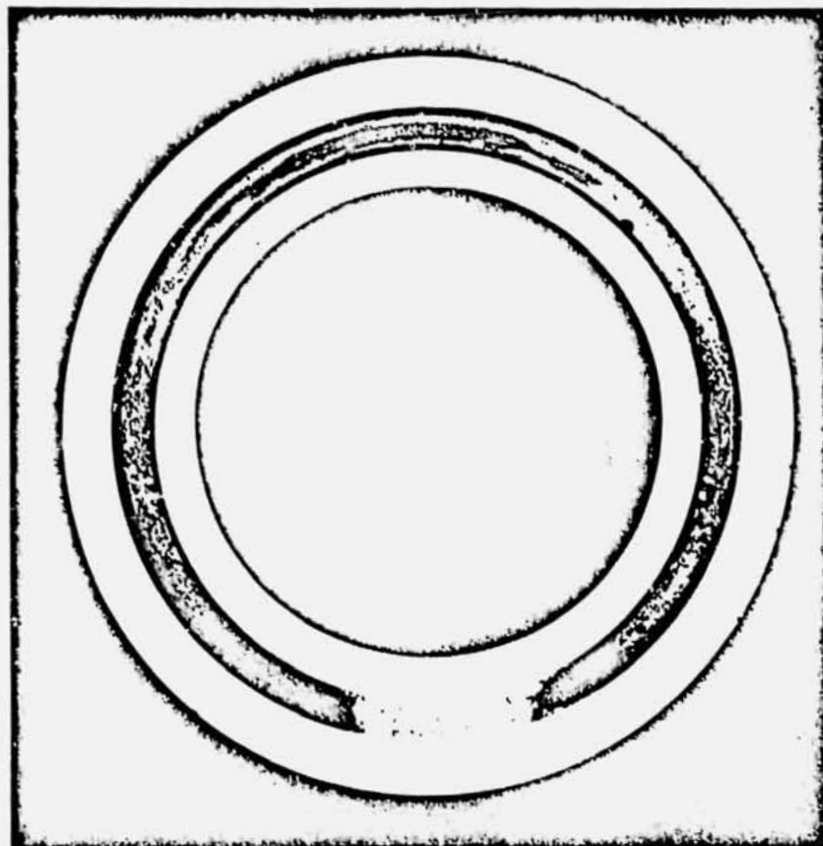
FIGURE I-9. SECTION MCN-2-3

A section of the right-hand filler metal ring groove is shown at 4X in Figure I-9. The accumulation of filler metal at the bottom of the ring groove indicates that the tube assembly was brazed in the orientation shown in this figure. Capillary forces were ineffective because the ring groove was too wide (0.055 inch). As a result, the filler metal collected in a puddle due to gravity and it did not form a smooth meniscus. Nevertheless, sufficient flow occurred to coat the entire surface of the ring groove with a thin film of filler metal.

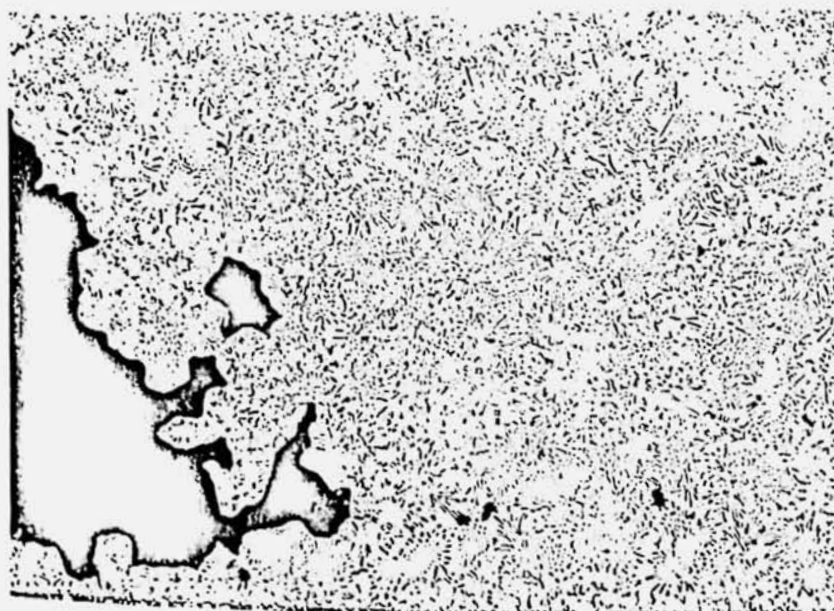
FIGURE I-10. SECTION MCN-2-3

A section near the left-hand edge of the accumulated filler metal is shown at 100X in Figure I-10. There are some isolated voids in this area. The microstructure is largely comprised of a eutectic phase and another phase resulting from the reaction of the filler metal with the base metal.

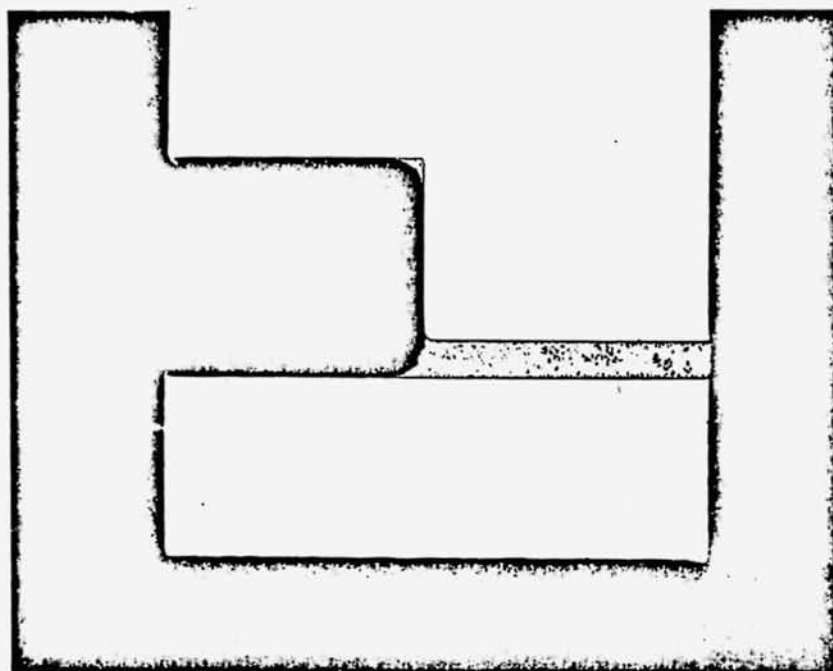
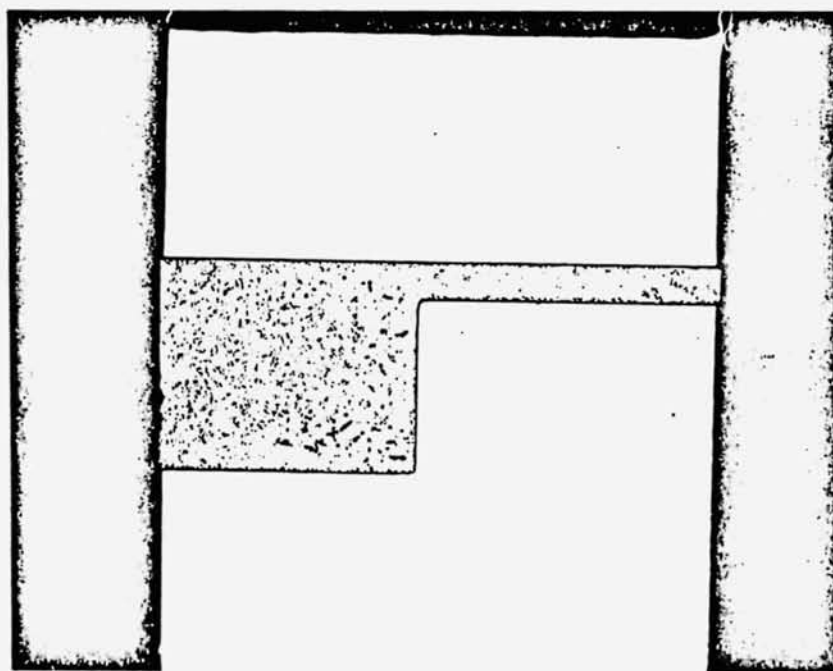
FIGURE I-11b. SECTION MCN-2-9

A complete cross section of the left-hand ring groove is shown at 20X in Figures I-11a and I-11b. In the section of the joint that was located at the 12 o'clock position during brazing (Figure I-11a), there was a fillet of filler metal in the corners of the ring groove, but the groove itself was empty. However, the surfaces of the groove were coated with a thin film of filler metal as it flowed into the joint between the tube and sleeve. In the section that was located at 6 o'clock during brazing (Figure I-11b), the ring groove was completely filled with accumulated filler metal as indicated by the radiograph of this area.

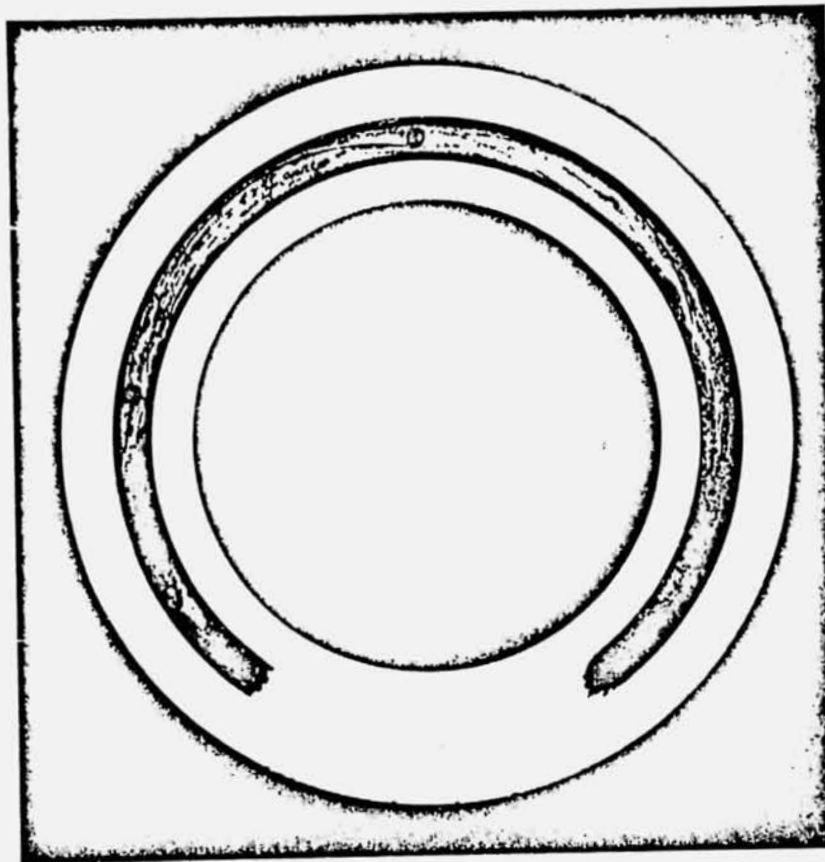
FIGURE I-13. SECTION MCN-3-2

A circumferential section through the right-hand ring groove of this sample is shown at 4X in Figure I-13. The location of the accumulated filler metal indicates that the tube assembly was brazed in the orientation shown in Figure I-13. Considerably more filler metal remained in the ring groove of this sample after brazing than in the corresponding ring groove of Sample MCN-2 (Figure I-9). Apparently, the filler metal did not flow as well as it did in the previous sample. As observed previously, however, the surfaces of the ring groove were coated with a thin film of filler metal.

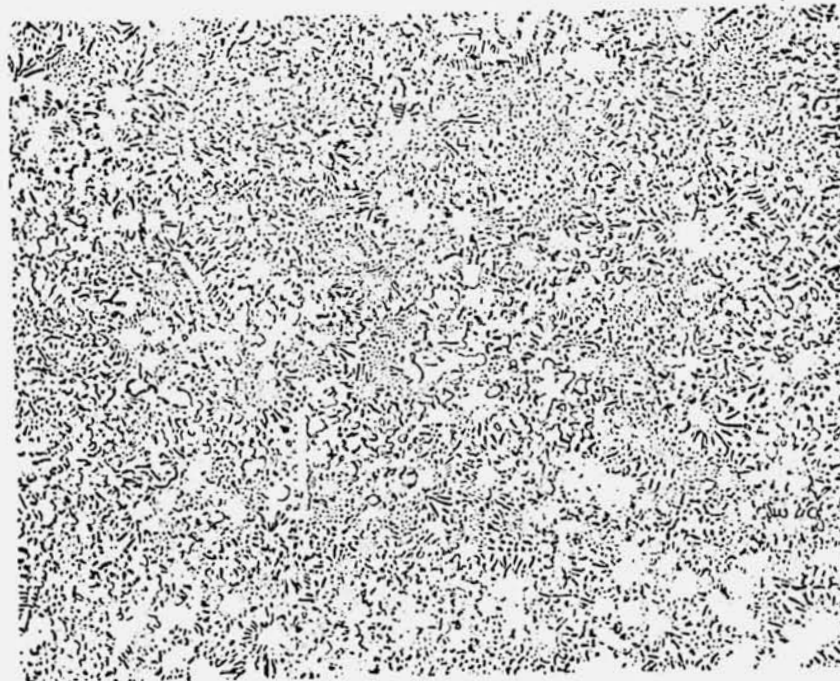
FIGURE I-14. SECTION MCN-3-2

The microstructure of the accumulated filler metal is shown at 100X in Figure I-14. It is similar in appearance to microstructures examined previously.

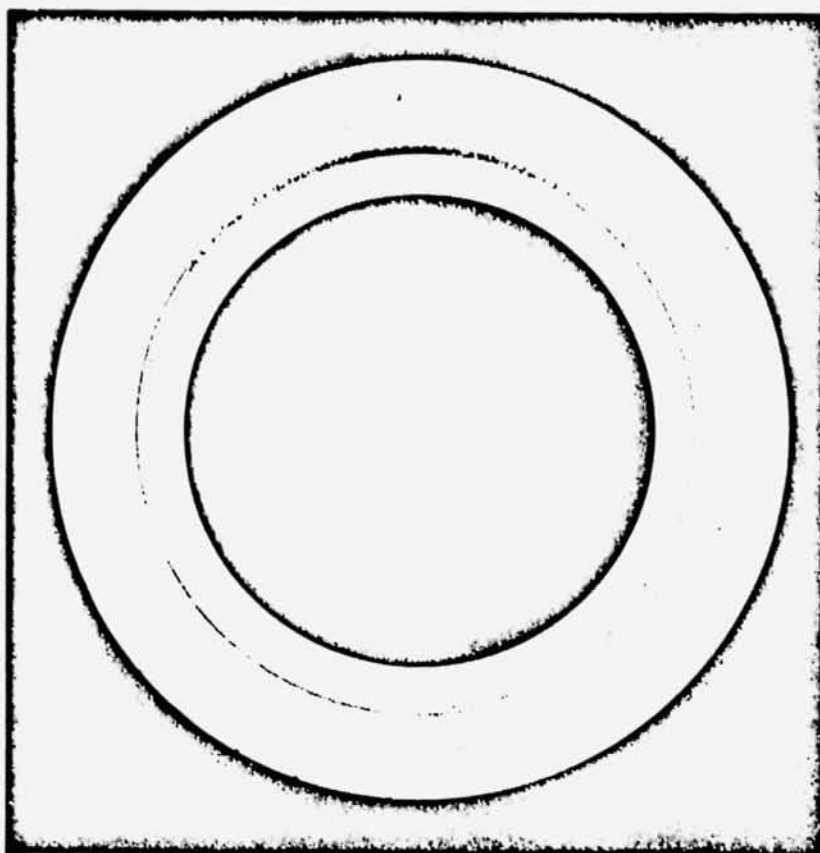
FIGURE I-15. SECTION MCN-3-4

A circumferential section between the ring grooves is shown at 4X in Figure I-15. The joint between the tube and the sleeve is essentially void for about 40 degrees of its circumference, and there are numerous voids on either side of this area. The void area was located at the top of the sample during the brazing cycle. In the radiographs of this joint, it was interpreted as an area of porosity. The remainder of this joint was largely defect-free.

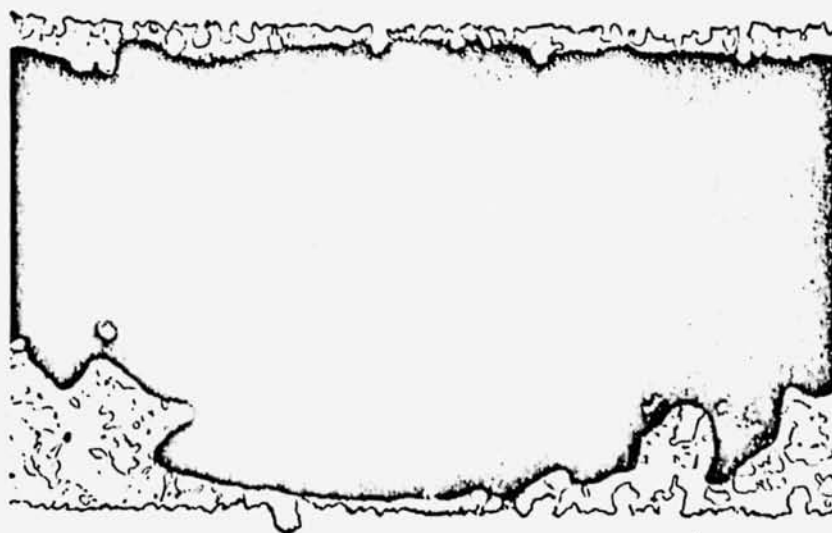
FIGURE I-16. SECTION MCN-3-4

A section of the void area is shown at 250X in Figure I-16. The presence of some filler metal and some material in a zone where the molten filler reacted with the base metal implies that filler metal was present in this area during the brazing cycle. However, much of it (presumably the eutectic phase) drained into areas deficient in filler metal before solidification was completed. There is one area along the lower interface where the filler metal appears to have penetrated the boundaries of a grain in the base metal.

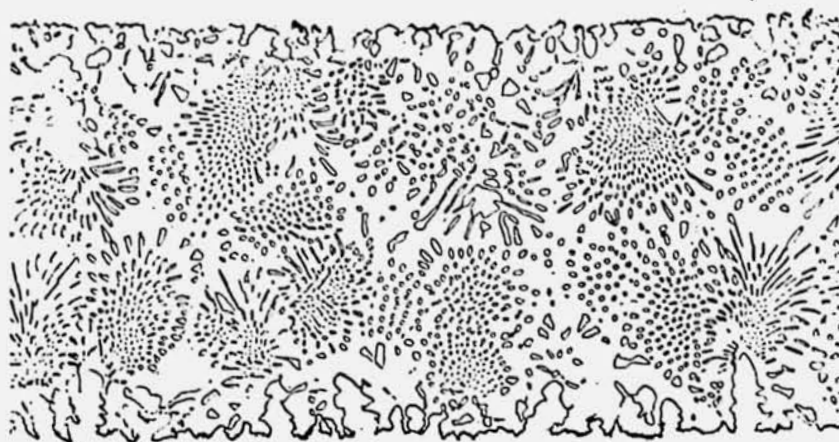
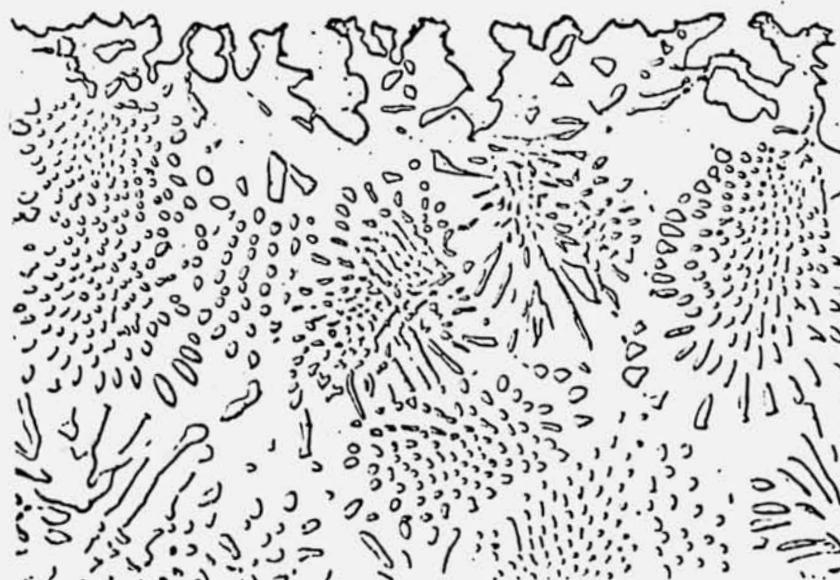
FIGURE I-17a. SECTION MCN-3-4

A defect-free area of this joint is shown at 250X and 500X in Figure I-17. The joint microstructure is similar to that observed in various sections of Sample MCN-2. However, the length of the particles along the interface indicates that more reaction between the molten filler metal and the base metal occurred in this sample than in Sample MCN-2.

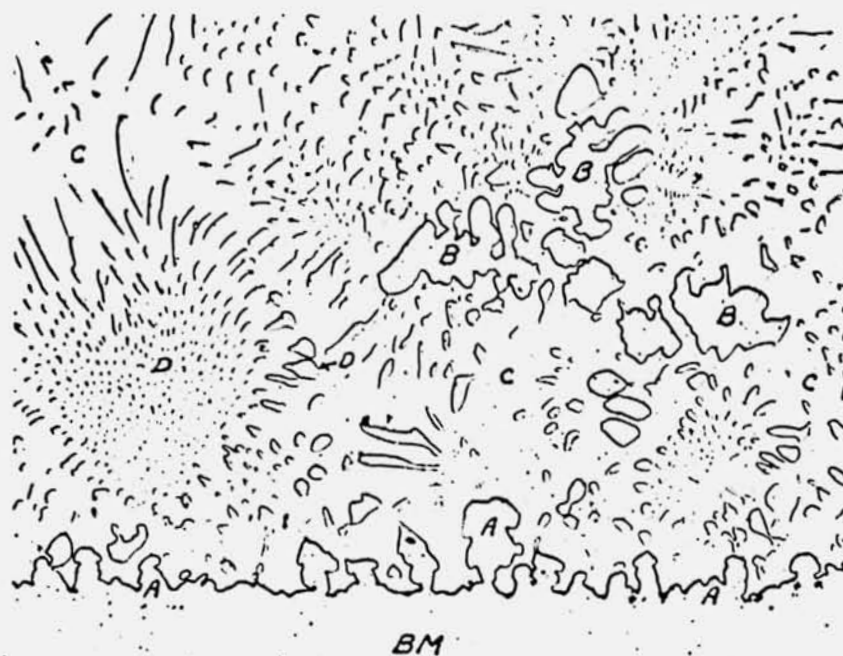
FIGURE I-19. SECTION MCN-2-1

The microstructure of a typical area along the joint interface of Section MCN-2-1 is shown in the unetched condition at a magnification of 250X in Figure I-19. Considerable reaction between the base metal and the molten filler metal occurred during the brazing cycle. In Section MCN-2-1, measurements indicated that a layer of base metal, 0.0005-inch-thick or less, was

dissolved by the molten filler metal to form another phase at the joint interface (areas labelled A in Figure I-19). Presumably, this is a nickel-copper phase because nickel and copper form a continuous series of solid solutions; on the other hand, the solubility of nickel in liquid silver is less than 0.5 weight percent at the brazing temperature.^(1,2) Based on its appearance in the unetched and etched condition, this phase also appears to be present in the filler metal matrix (areas labelled B in Figure I-19).

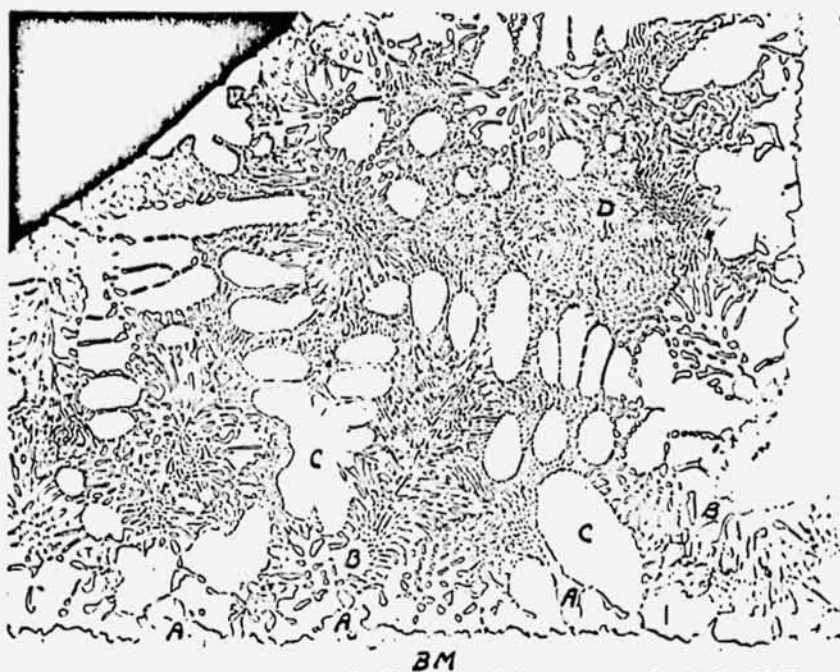
FIGURE 21a. TEE JOINT

An unetched section of the nickel tee-joint is shown at 250X in Figure I-21a; for direct comparison, a section from MCN-2 is shown at the same magnification in Figure I-21b (this figure is identical to I-4). The microstructures of these joints reflect differences attributable to the brazing conditions. The amount and distribution of the copper-rich phase (A in Figure I-21a and I-21b) indicates that more reaction between the base metal and filler metal occurred in the exothermically brazed joint than in the furnace brazed joint. However, the width of the reaction zone at the interface was comparable for both joints. The microstructure of areas at some distance from the joint interface differs considerably. In the furnace-brazed joint (Figure I-21a), there is a silver-rich dendritic phase (C) dispersed in a matrix of the silver-copper eutectic (D). In the exothermic-brazed joint (Figure I-21b), the following phases are present: a copper-rich phase (A), a phase that is essentially pure silver (B), and a phase that was not identified (C).

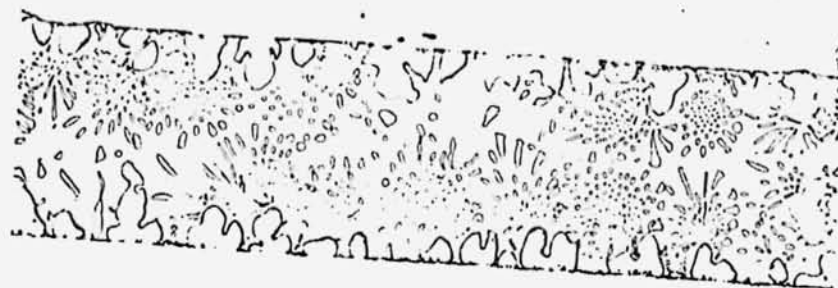
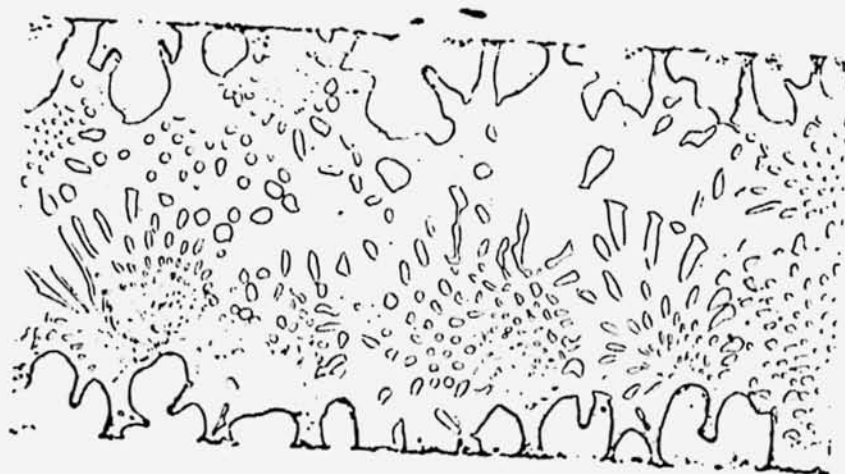
FIGURE II-4a. SECTION MCS-1-1

Selected areas of this joint are shown in the unetched condition at magnifications of 250X and 500X in Figures II-4a and II-4b. The microstructure between the joint interfaces appears to consist of a three-phase structure. The dissolution of the base metal by the molten filler metal is clearly evident. The width of the joint between interfaces is 0.0044 inch; some products of the base metal-filler metal reaction extend about 0.001 inch from the interface.

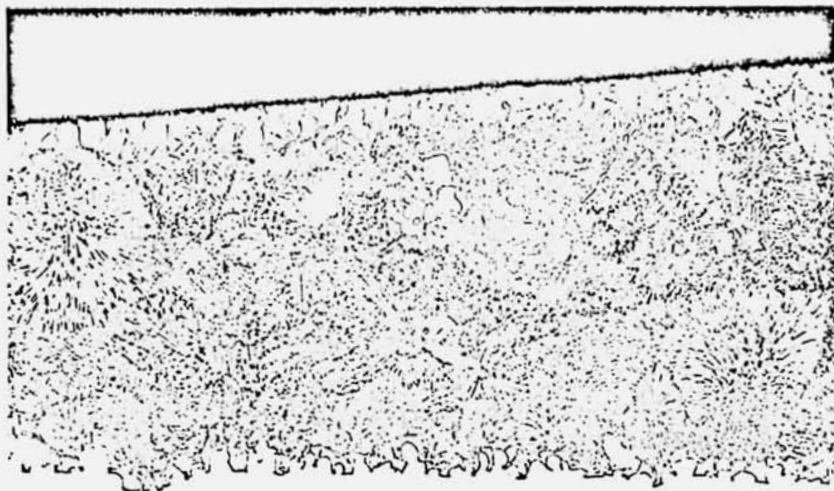
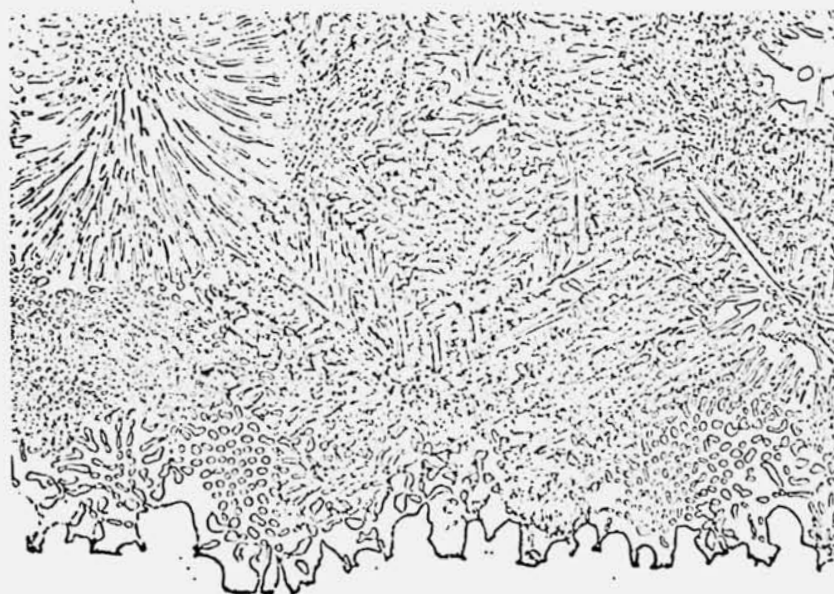
FIGURE II-6a. SECTION MCS-1-2

The microstructure of an area of accumulated filler metal is shown in the unetched condition at 250X and 500X in Figures II-6a and II-6b. Reaction between the base metal and molten filler metal at the interface is clearly evident. The microstructure of the bulk filler metal is quite complex, consisting of products from the base metal-filler metal reaction and possibly some silver-copper eutectic.

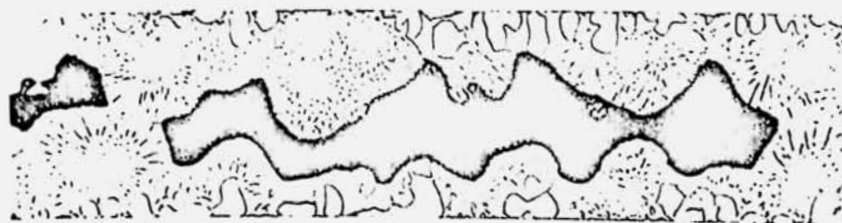
FIGURE II-8. SECTION MCS-1-4

A section of void area is shown at 100X in Figure II-8. The entire area between the joint interface appears to have been once filled with filler metal; the void occurred when filler metal drained from this area into others that were deficient in filler metal.

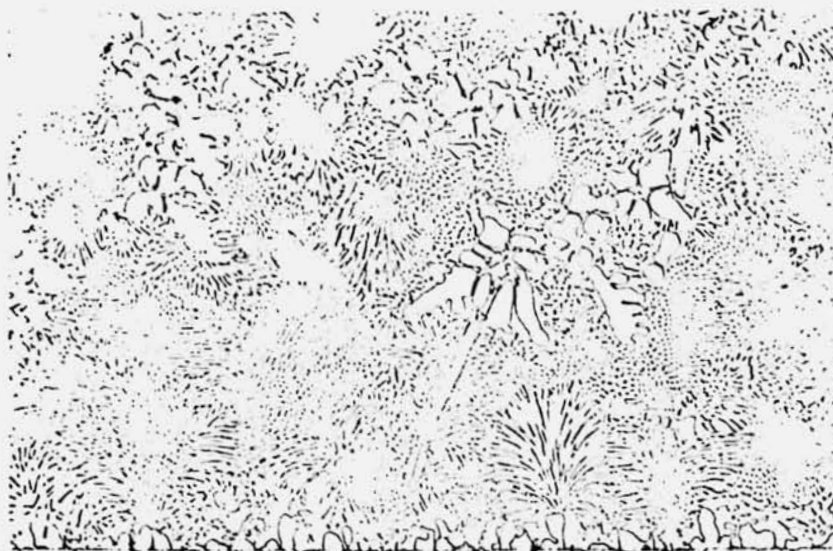
FIGURE II-9. SECTION MCS-1-4

An area of the filler metal accumulated inside the tube is shown at 250X in Figure II-9. The microstructure of this area is somewhat different than that shown in Figure II-6a; a dendritic phase is present in a matrix of filler metal. The amount of reaction between the base metal and molten filler metal is comparable in both areas.

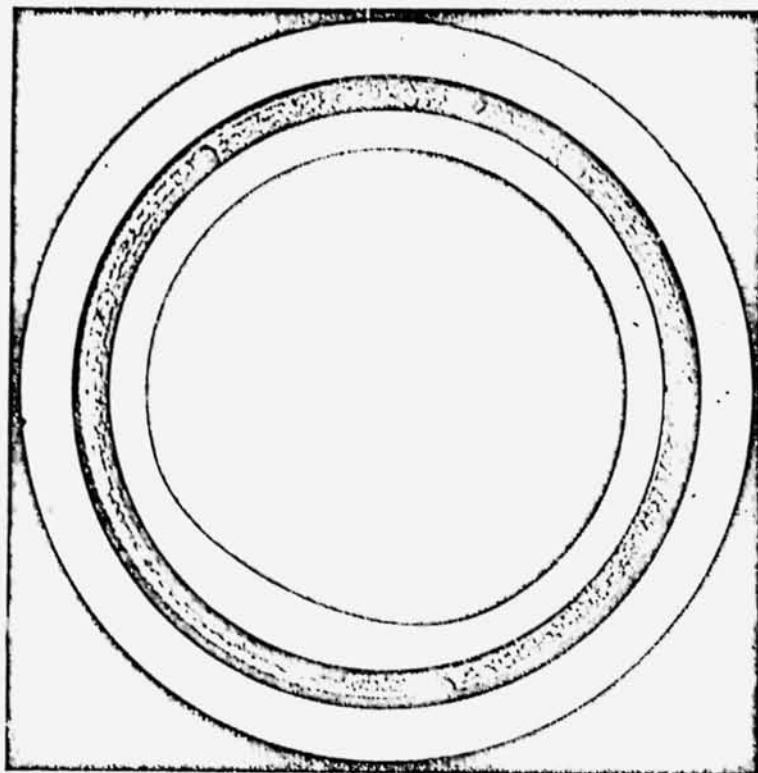
FIGURE II-11. SECTION MCS-1-9

A section through the left-hand filler metal ring groove is shown at 4X in Figure II-11. The ring groove is empty; however, its surfaces are covered with a very thin film of filler metal. Filler metal has accumulated at the bottom inside of the tube. The microstructure of the accumulated filler metal is similar to that observed in other sections of this joint.

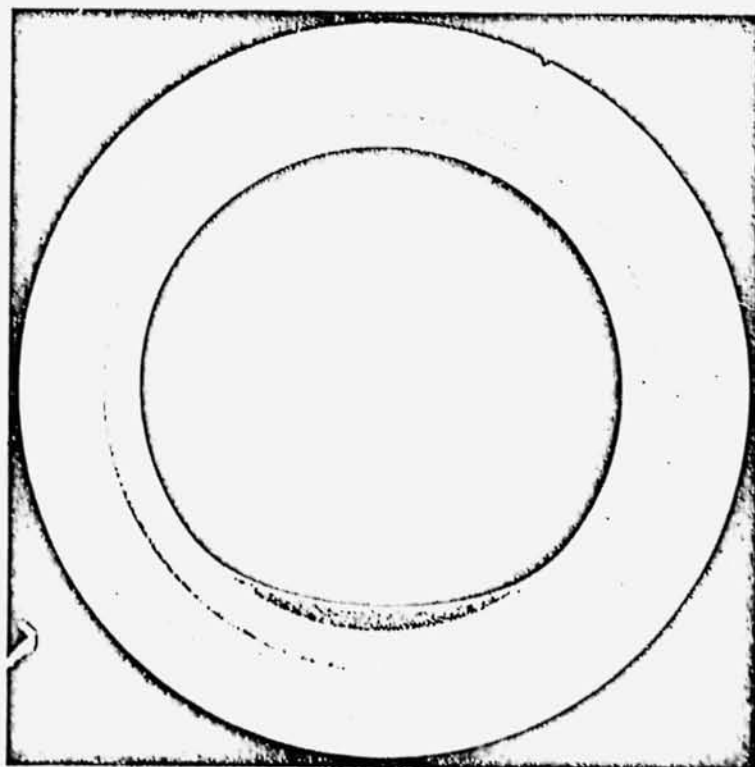
FIGURE II-13. SECTION MCS-2-4

The full circumferential joint between the tube and sleeve is shown at 4X in Figure II-13. The joint quality was excellent and there were no void areas of significance. A section of this joint is shown in the unetched condition at 250X in Figure II-14a; the same section is shown etched in Figure II-14b. The joint microstructure appears similar to those observed in sections from Sample MCS-1.

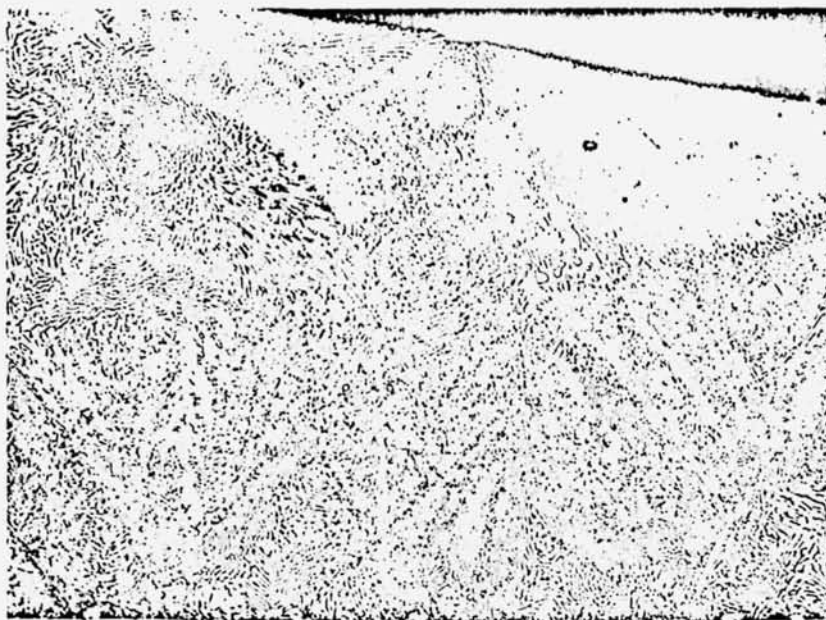
FIGURE II-15. SECTION MCS-2-4

Filler metal has accumulated on the inside bottom of the tube. The microstructure of an area of accumulated filler metal is shown in Figure II-15 at 250X. There appears to be little reaction at the interface between the filler metal and base metal; the microstructure is comprised primarily of the silver-copper eutectic.

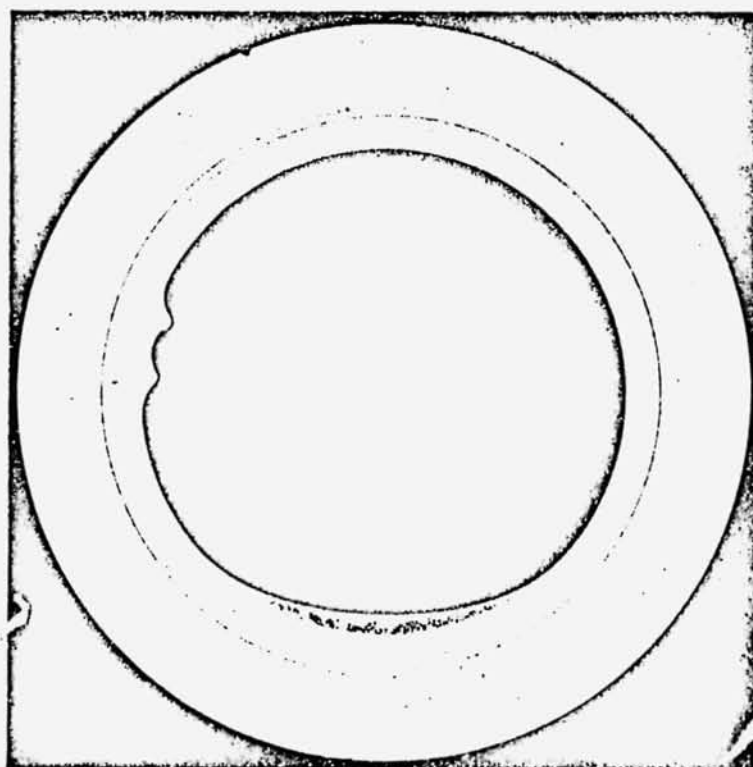
FIGURE II-16. SECTION MCS-2-7

The circumferential joint between the tube and sleeve is shown at 4X in Figure II-16. Excellent flow of the filler metal during brazing occurred. The joint is completely filled; there were a few small isolated voids of little significance. Filler metal flowed through the slits in the center of the tube and accumulated in the bottom inside of the tube. As it did so, it brazed the thermocouple to the inside of the tube. The joint microstructure and the microstructure of the accumulated filler metal is similar to those observed previously.

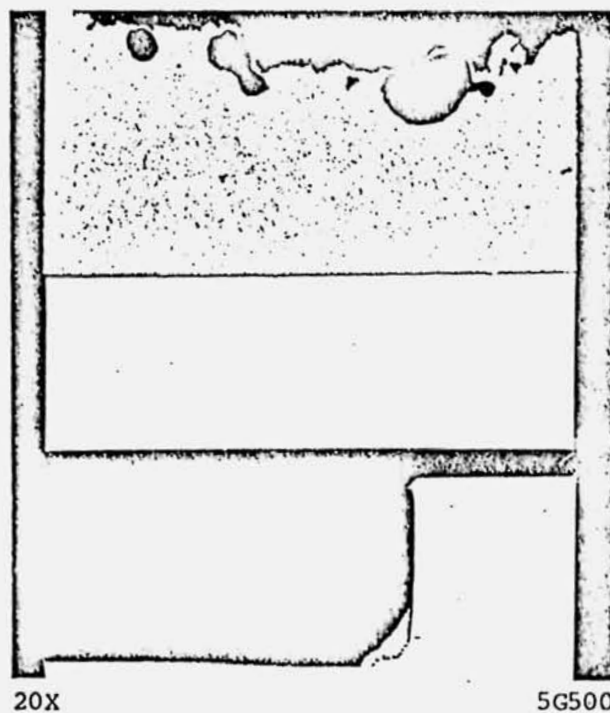
FIGURE II-18b. SECTION MCS-3-2

The lower half of this section is shown at 20X in Figure II-18b. The ring groove is essentially void except for some filler metal remaining in one corner. This section of joint between the tube and sleeve is completely void; however, the joint in the upper half of this section was well filled with filler metal. The presence of voids in this area was indicated by radiography. As observed previously with Samples MCS-1 and MCS-2, filler metal accumulated on the bottom inside of the tube during brazing. However, the surface of the accumulated filler metal was extremely rough and there were numerous indications of voids or porosity. In contrast, the surface of the accumulated filler metal in the other two samples (MCS-1 and MCS-2) was very smooth. Due to an equipment malfunction, the maximum temperature to which Sample MCS-3 was heated during brazing was about 100 F (37.8 C) lower than the temperature to which the other samples were heated. Apparently, the surface roughness is associated with the manner in which the filler metal flowed and solidified.

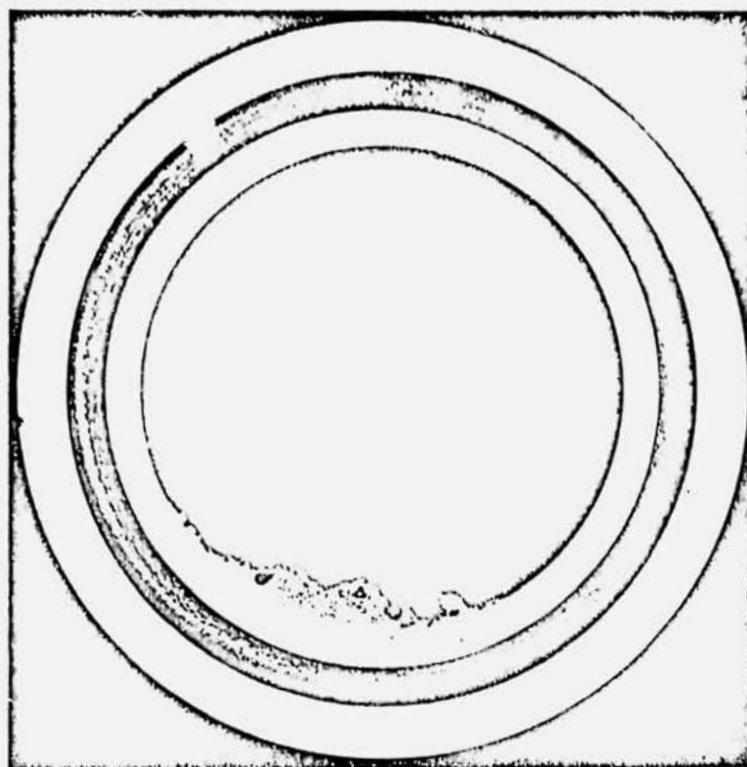
FIGURE II-19a. SECTION MCS-3-3

A section through the right-hand ring groove is shown at 4X in Figure II-19a. The ring groove is void; however, a thin film of filler metal was present on its surfaces. The surface roughness of the filler metal that accumulated inside the tube during brazing is clearly evident. An area of accumulated filler metal is shown at 100X in Figure II-19b. Voids or pores are present in this area. The microstructure of this area is somewhat different from that observed in similar sections from Samples MCS-1 and MCS-2. Although the maximum brazing temperature for Sample MCS-3 was less than it was for the other two samples, the products of the reaction between the base metal and the molten filler metal appear to be dispersed in larger amounts throughout the microstructure.

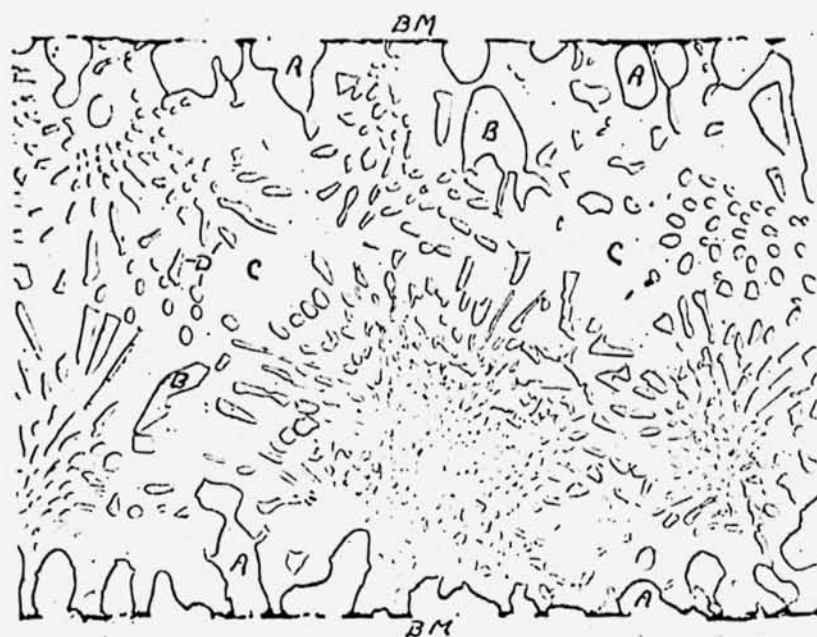
FIGURE II-22. SECTION MCS-2-4

The microstructure of a typical area of the joint between the tube and sleeve in Section MCS-2-4 is shown in the unetched condition at a magnification of 500X in Figure II-22. Considerable reaction between the base metal and the molten filler metal occurred during brazing. In Section MCS-2-4, measurements indicated that a layer of base metal (about 0.0005-inch-thick) was dissolved by the molten filler metal to form another phase at the joint interface (areas labelled A in Figure II-22). Presumably, this is a copper-nickel phase because copper and nickel form a continuous series of solid solutions. The other elements contained in the base metal have a limited solubility in the molten constituents of the filler metal. This phase appears to disperse also in the area between the point interfaces (areas labelled B in Figure II-22).

- (1) The phase (A in Figure II-22) along the joint interface that was produced by dissolution of the base metal by the molten filler metal contained 73 percent (or more) copper, some silver (about 6 percent), and a small amount of nickel. Chromium and iron were not detected in this area.
- (2) The composition of the phases labelled B and D in Figure II-22 was almost identical to that of the phase labelled A. These particles resulted from the base metal-filler metal reaction and became detached as dissolution of the base metal progressed.
- (3) The light areas (C in Figure II-22) are composed of essentially pure silver.
- (4) The presence of nickel, chromium, and iron in the base metal (E in Figure II-22) is indicated by the X-ray images for these elements.
